Cross Hill House

Extent of Remedial Repairs and Maintenance
Requiring Listed Building Consent

Design, Access and Heritage Statement

December 2010

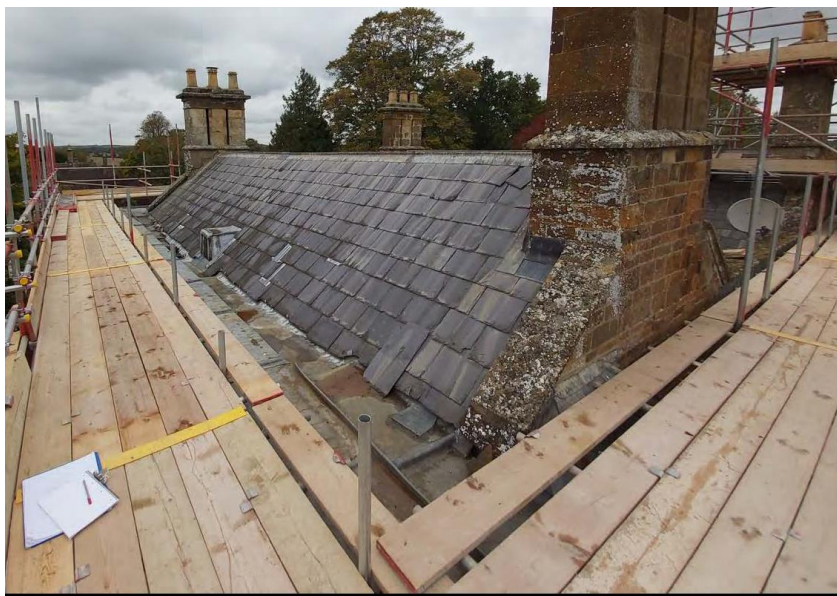
This image shows the 4 chimney stacks to the main house, taken from the south east corner.

Upon close inspection it would appear that the chimneys have been the subject of a fair amount of rebuilding and repair over the life of the building. 2 chimneys are in relatively original condition and 2 have been rebuilt at some time in the past. The original chimneys at the south west and north east corners have flue “barrels” constructed in a light shade of Cotswold stone to match the stonework used as architectural emphasis on the south elevation. Here the Cotswold stone is used for the pilasters, cornice/coping, band courses and central door case.

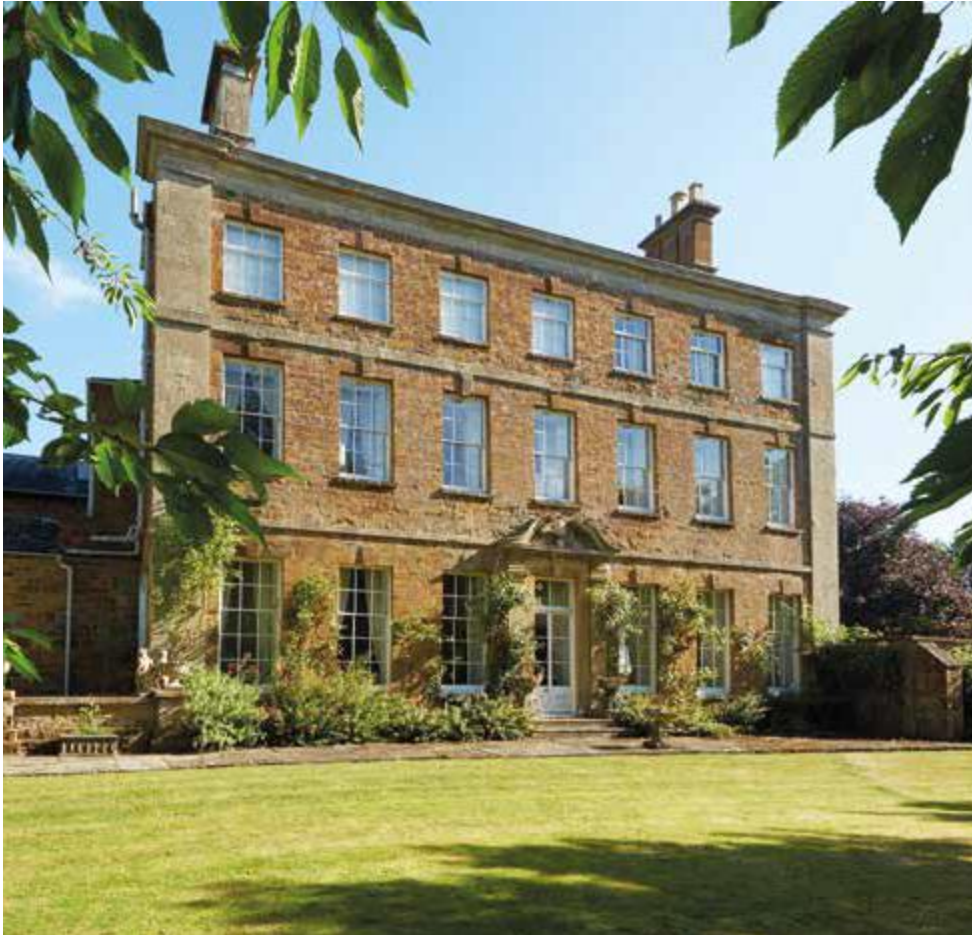
South elevation showing use of light-coloured Cotswold stone as an architectural design feature. The same stone is used in the barrels of the SW and NE chimneys.

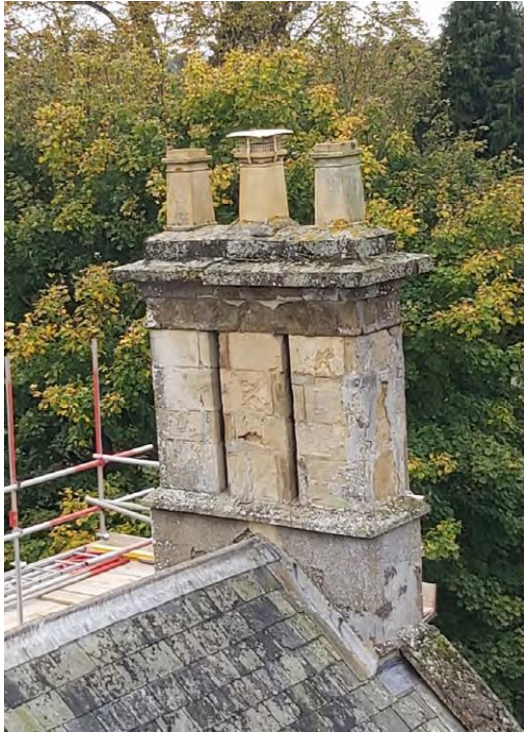
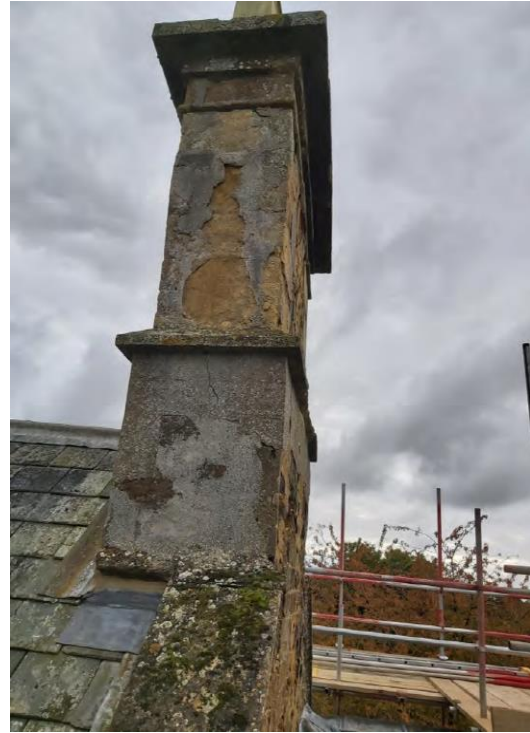
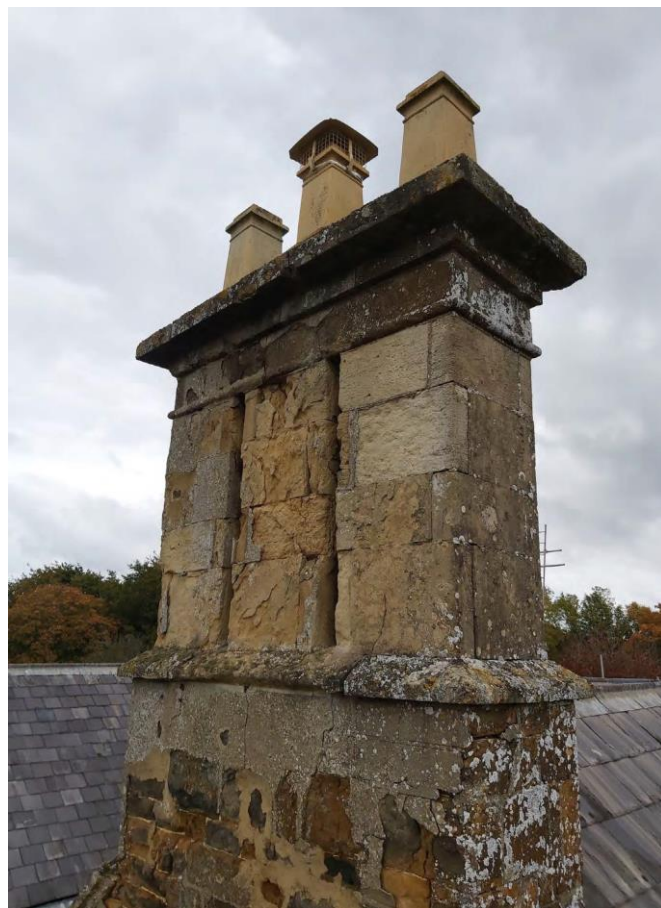
South West Chimney

Chimneys at the south east and north west corners have barrels constructed in the honey-coloured Horton stone used for general masonry to in all other construction of Cross Hill House. Extensive use of cement-based renders and pointing has been utilised in the past, presumably, to cover-up weathered and decayed stone. Unfortunately, the use of cement has contributed to the further deterioration of original stonework and will likely cause further damage when stone is dismantled for the necessary repairs. – see images below.

It will be noted from the structural engineers report that 3 of the chimney stacks are in such poor condition that they will be taken down to, at least, roof level in order to safely replace and repair the extensive damage to the stonework. The stacks in question are the NW, the NE and the SW. It is also apparent that some of the ashlar stonework beneath the lower drip course of each stack is in poor condition and will require some attention. The full extent of repair to all 3 stacks and the stone below can not be fully ascertained until the stacks have been carefully taken down as described in the Specification of Workmanship and Materials. Details of all repairs will be at the decision of the Historic Buildings Specialist, and confirmed as required with the Conservation Officer.

As it is apparent that the original design of all 4 of the chimneys allowed for the individual flue barrels to be constructed in Cotswold stone rather than the local Horton stone, it is proposed that appropriately selected Cotswold stone be used for all 3 sets of barrels. Where possible, original stone will be retained, however, given its condition, it is thought unlikely that much will be re-useable.

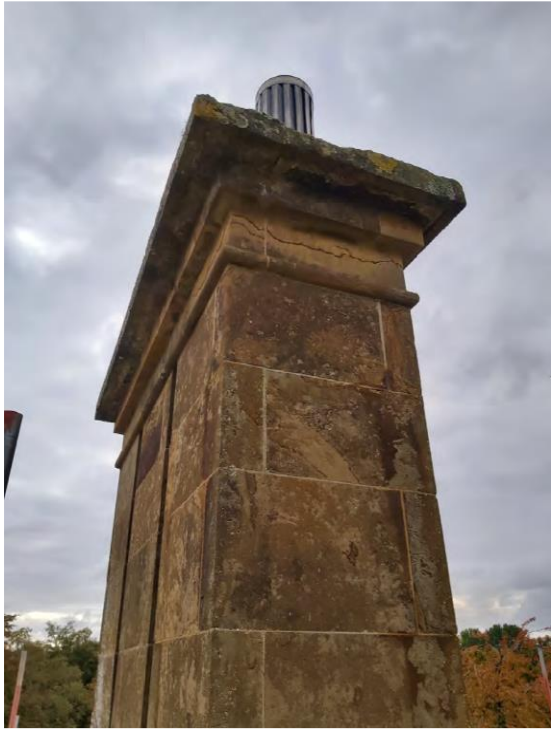
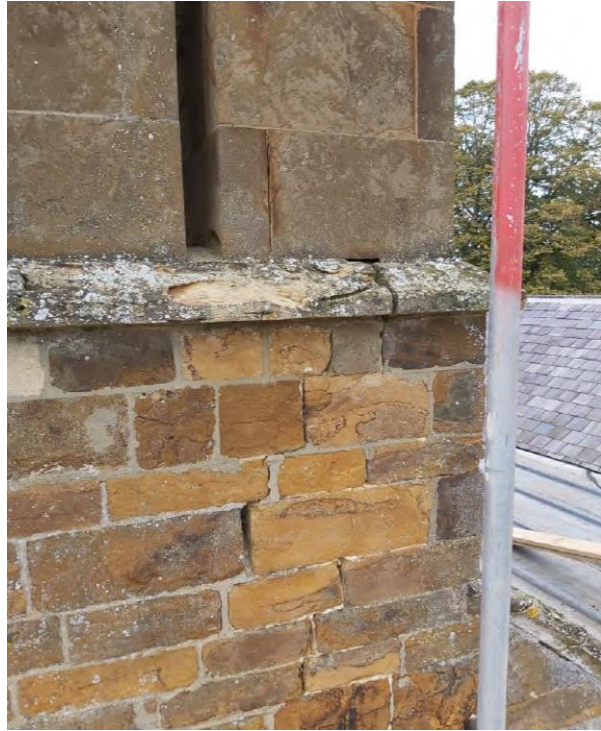
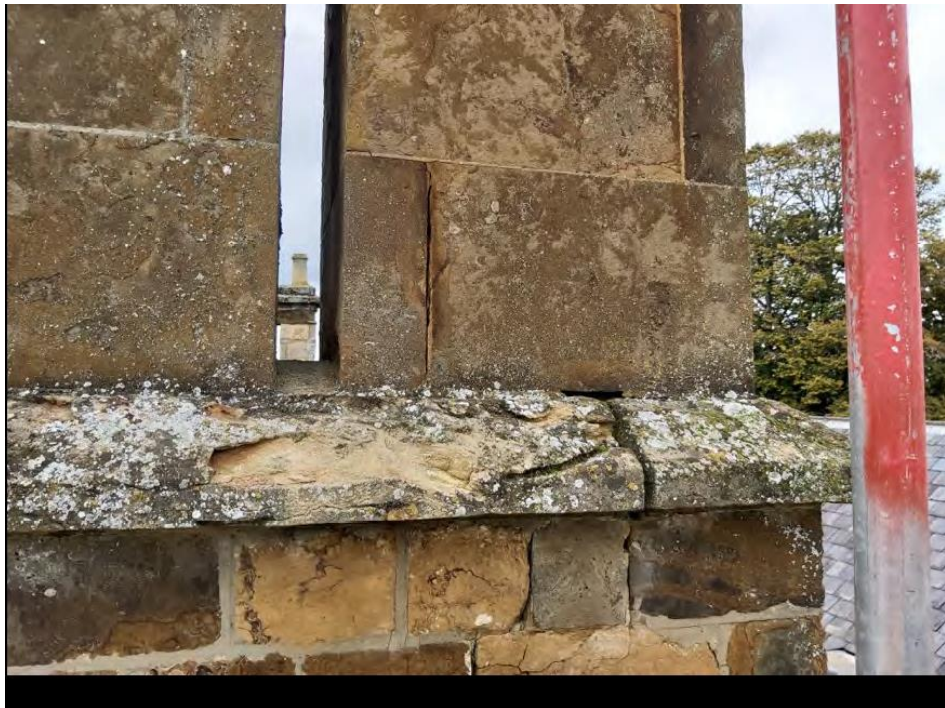
South East Chimney

It appears that the SE stack has been rebuilt at some time in the mid to second half of the 20th century. The material used is all from this date, with no original material remaining. Whilst this stack is relatively structurally sound, it is proposed that it be taken down to the lower drip course to replace the barrels in the correct Cotswold stone thus restoring the original architectural composition to the building. The use of Cotswold stone was a vitally important aspect of the original design and as no historic fabric will be lost in this process, it is considered a worthwhile operation and of overall benefit to the conservation of the historical design.

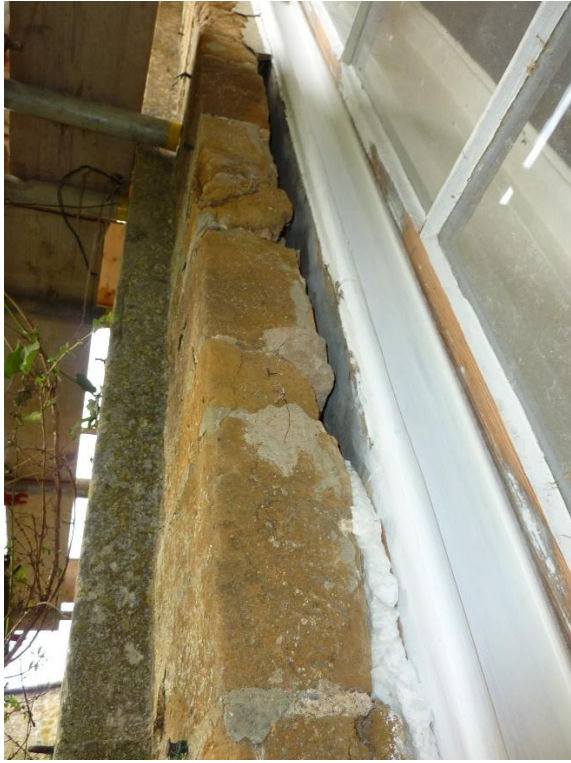
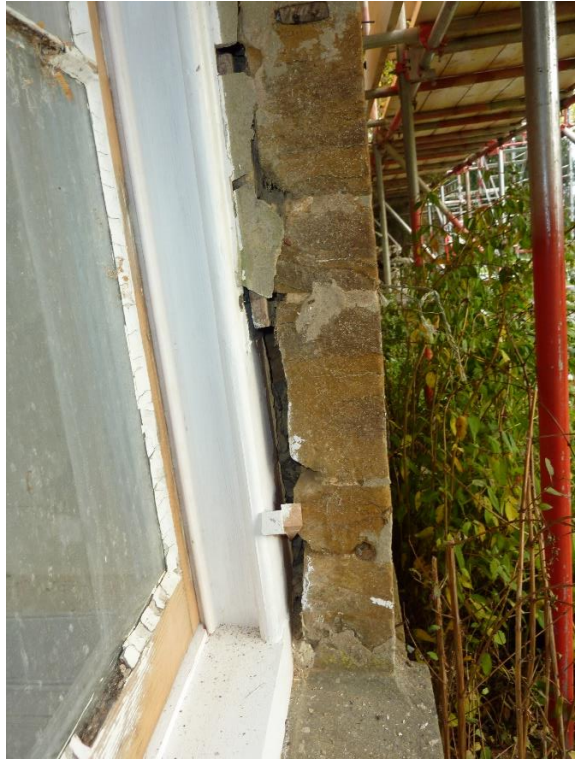
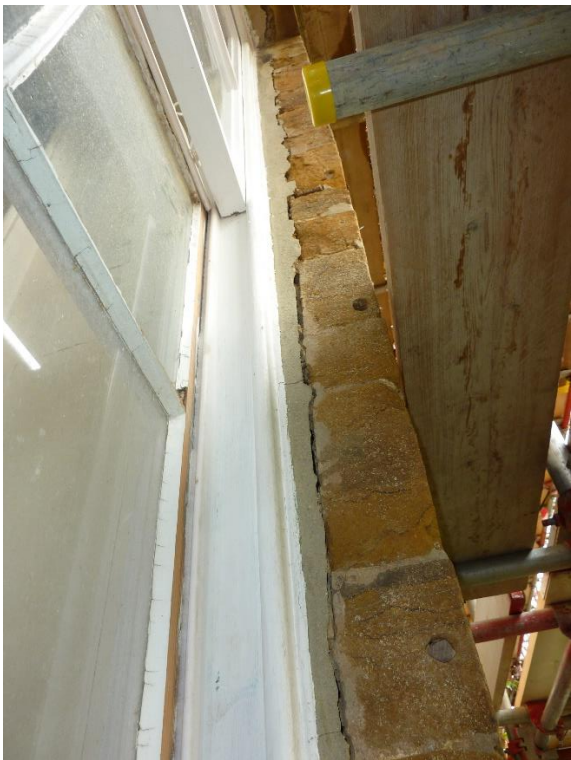
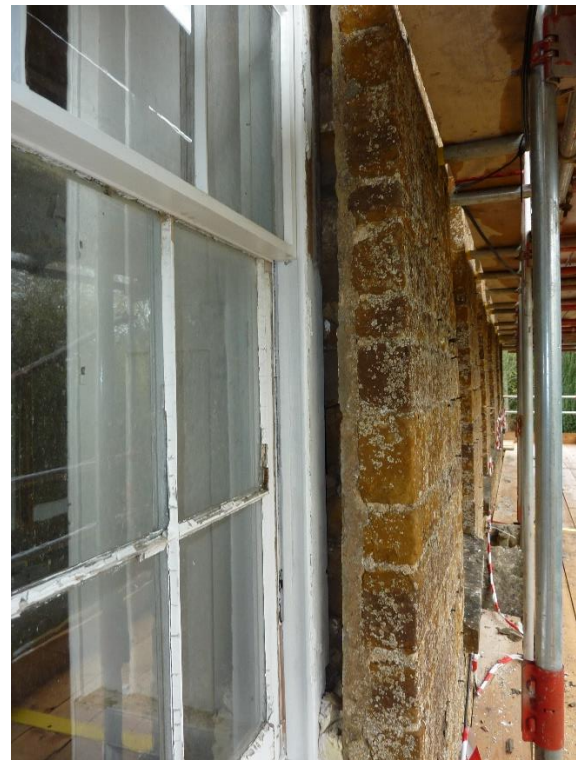
Currently the gap between the facing stone and the recessed sash windows has been filled with large cement-based mortar fillets. Cracking and the failure of the cement fillets are typical and suggest the continuation of the problem - see images below.

Cracked and failed cement fillets between south sash windows and facing ashlar stonework

It is proposed that matching Horton stone fillets be used to replace all the cement where gaps exceed 25mm, laid in lime putty mortar and pinned to existing stone with stainless steel rods and or straps, so as not to disturb the facing stone. Where the gap is beneath 25mm, it shall be filled with the mortar mix as specified for rubble stone (see Specification of Workmanship and Materials), i.e., mortar to match existing but with added aggregate.

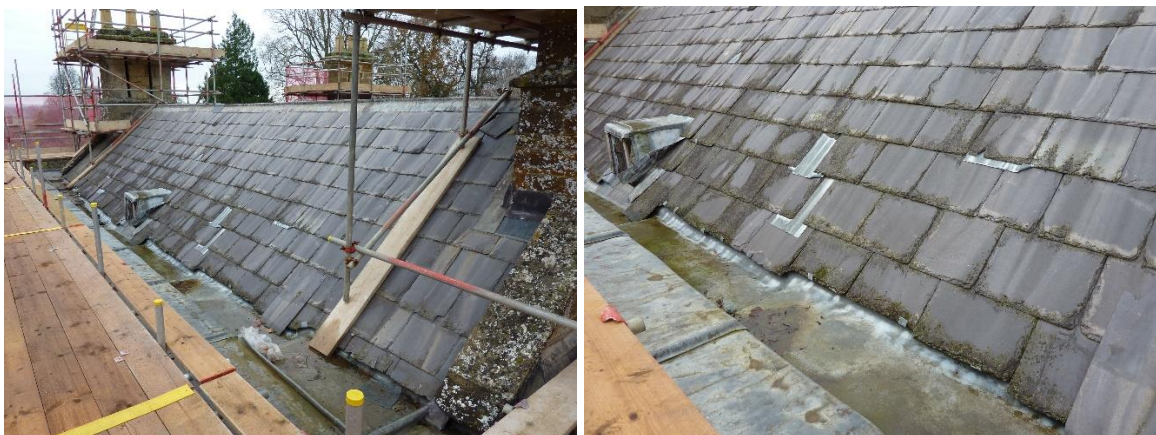
Roof Slope A

Roof slope A has a number of slipped slates and past repairs suggesting that the securing nails have reached the end of their useful life. This roof slope needs to be slipped and re-covered. The slates on this slope are larger than usual and there will inevitably be a need to source additional matching slates. If possible, second-hand slates will be sourced from reputable reclamation yards, however if none can be found then new welsh slate, cut to the correct size will be obtained. The Historic Building Consultant will ensure that any replacement slate will accurately match existing.

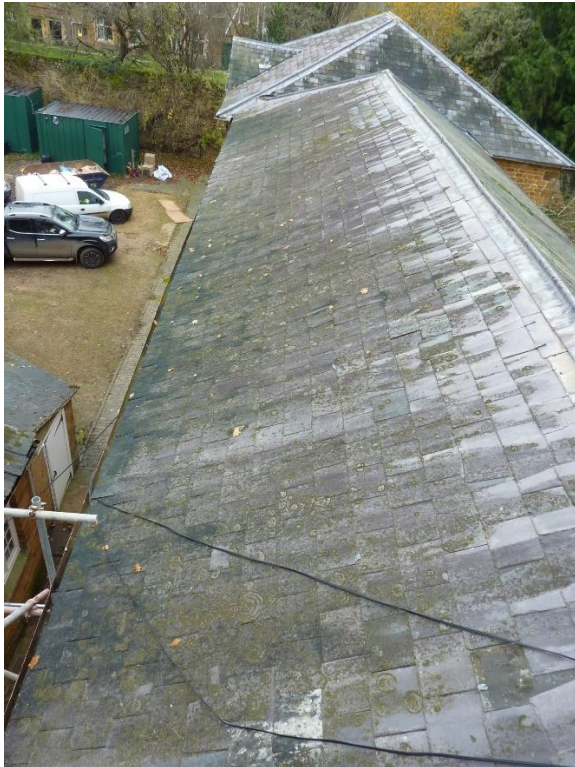
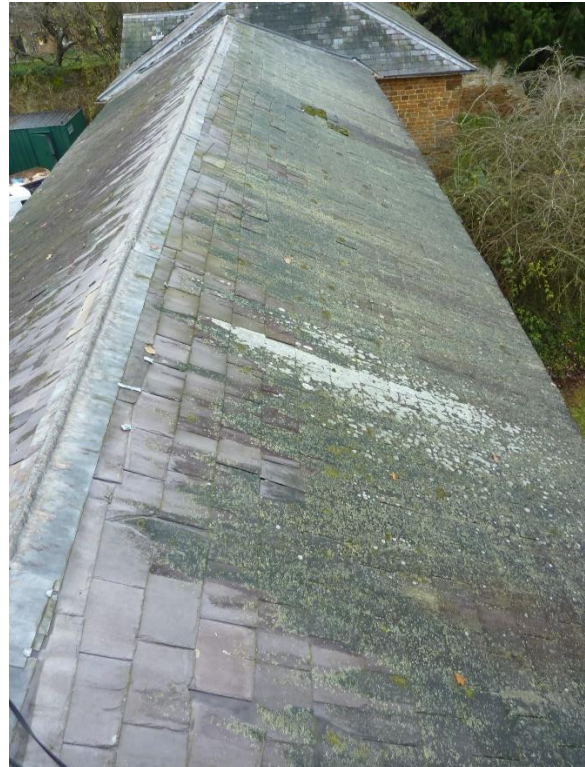
Roof slope I (left) and J (right)

Both these roof slopes appear to be relatively sound, however there are a large number of tangles present indicating that slates have started to slip. Permission is sought to strip and re-cover both these slopes as it is more economical to undertake this work now, rather than in the future. It also makes sense to re-cover the hip K at the same time.

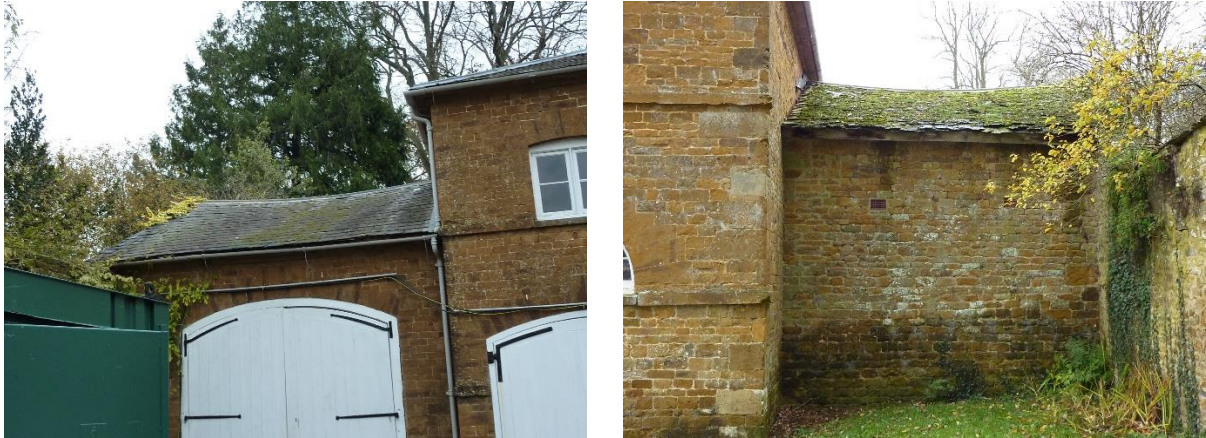
Roof slopes P (left) and Q (right)

The structural engineer's report details the structural problems with this roof and the proposed method to remedy the defects. In general, the whole roof has dropped causing spread at the eaves. The ridge has followed the roof down leaving the distinct "dip". The entire roof needs to be stripped, the structure raised onto a new ridge beam and rafters repaired at eaves. The covering will then be re-laid with all new leadwork.

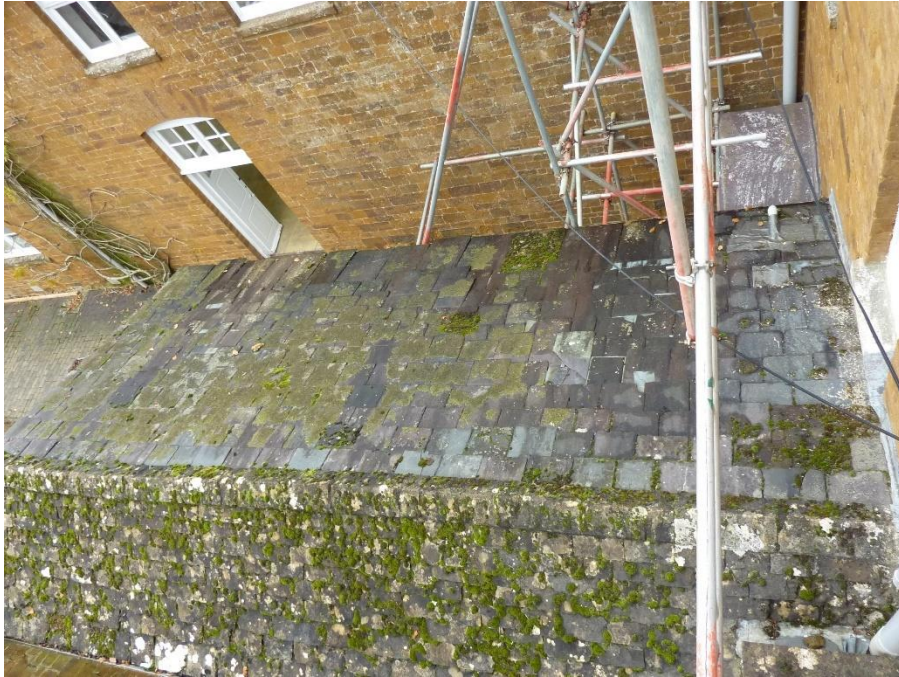
Roof slope G

The slates on this north facing slope have started to slip and there are a number of broken and split slates. This slope will need to be re-covered. Extreme care will need to be taken to lift the stone ridge so that it can be reinstated. Any damaged stone will be replaced in matching stone and all ridge pieces laid in lime mortar.

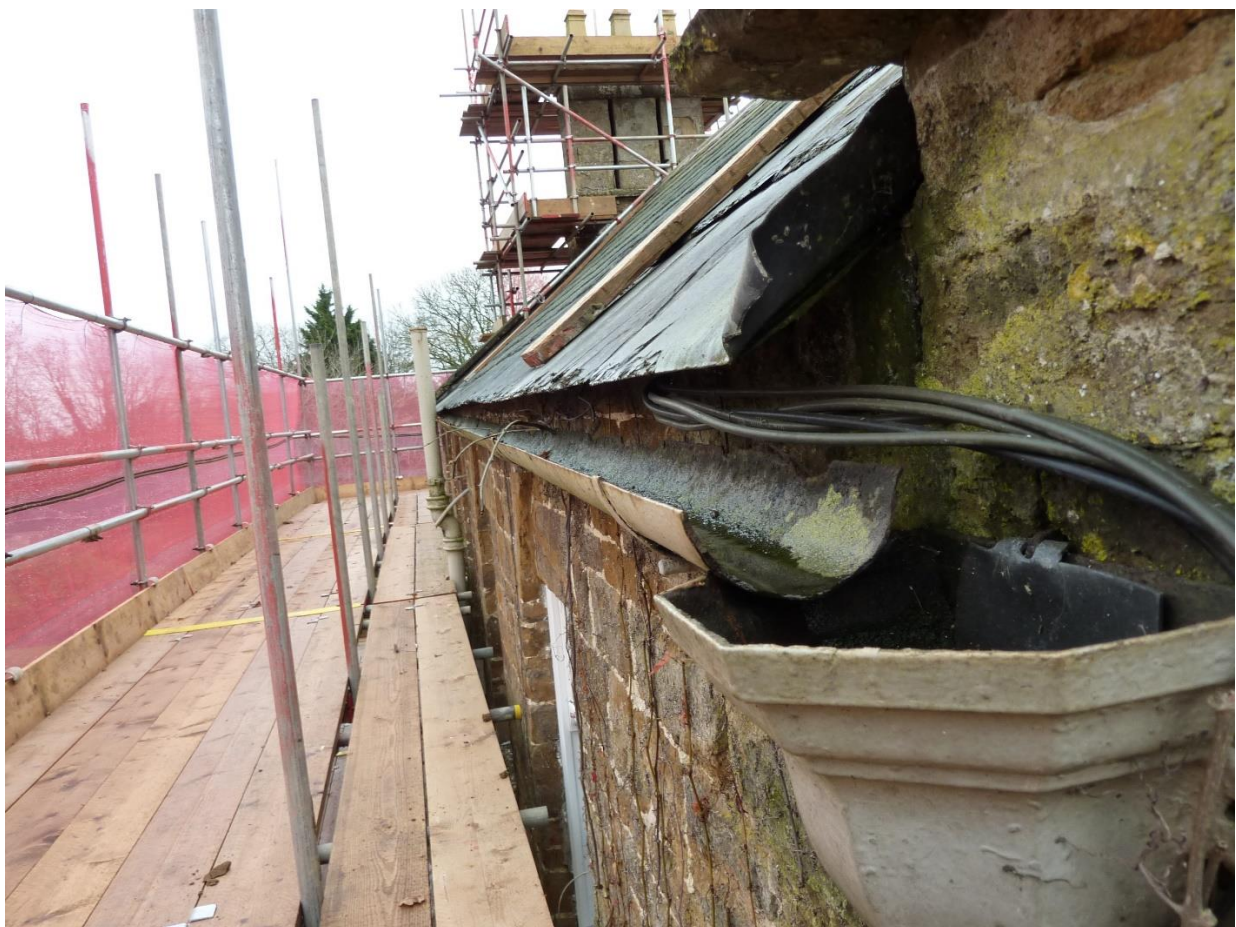
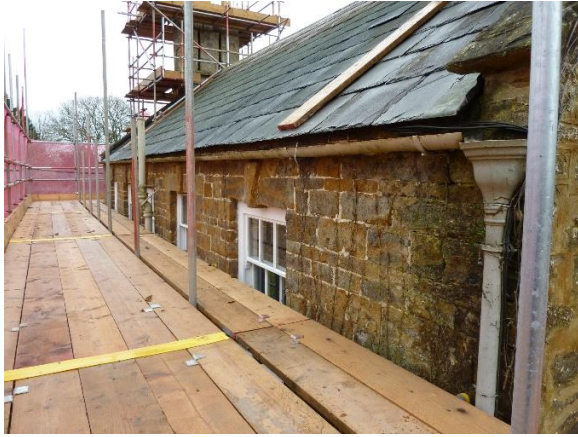
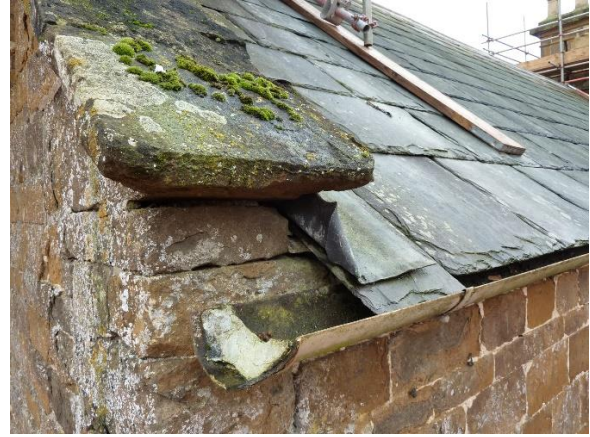
All existing rainwater goods are cast iron. Most are in good condition, however where downpipes, junctions or other details are damaged, they will be replaced with matching cast iron sections. The gutter serving Roof Slope D will need to be replaced due to sever corrosion to the rear edge. The replacement guttering will be half round to match existing and of the same width. Where possible, existing brackets will be re-used, supplemented with matching brackets as necessary. See photos below.

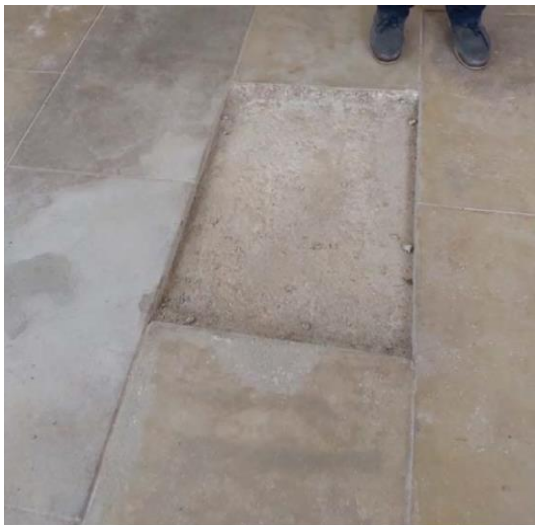
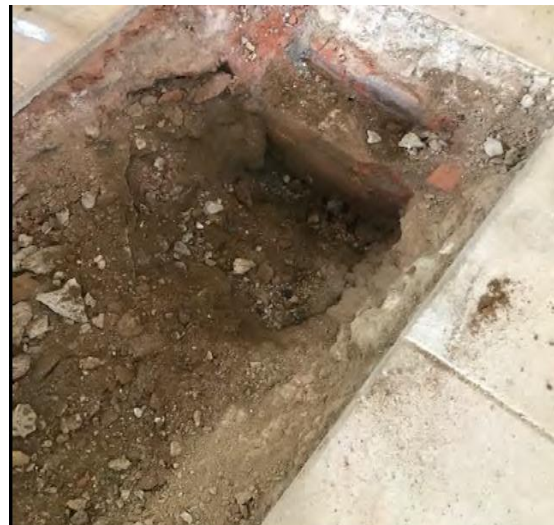
The existing Kitchen floor covering is a modern thin, rectangular limestone laid on a thin bed adhesive on concrete, as shown above. The concrete base averages about 4 inches (100mm) thick and in turn is laid on rubble hardcore, directly over the soil below. There is no damp-proof membrane and no insulation. It is estimated that this floor construction probably dates from the 1950's although the limestone covering is probably more recent.

This application seeks consent to break-up the entire 1950's construction and remove all material from site. The sub-soil will then be excavated to allow for a new floor construction

incorporating insulation to current Building Regulation standards and underfloor heating set within a screed. It will then be topped with new English limestone flagstones.
