Cross Hill House

Extent of Remedial Repairs and Maintenance
Requiring Listed Building Consent

Design, Access and Heritage Statement

December 2010

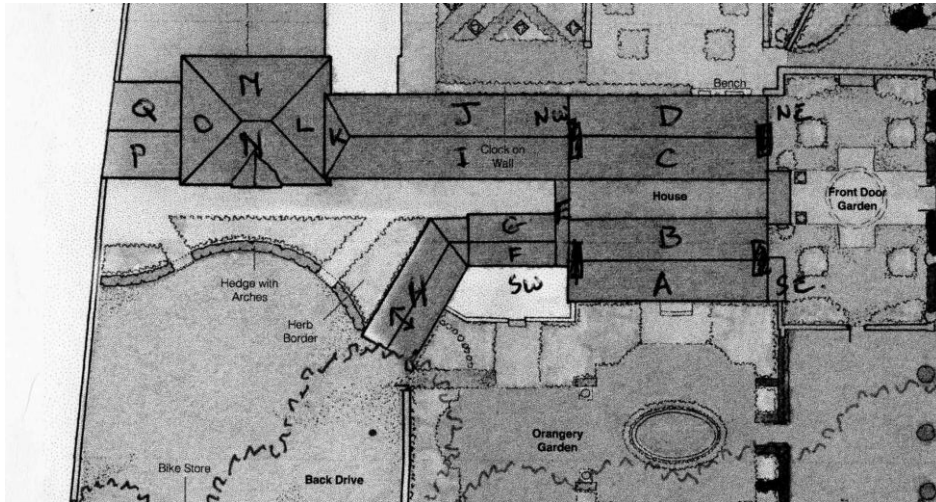
Roof Plan identifying roof slopes

Roof slopes needing re-covering

Roof slope A has a number of slipped slates and past repairs suggesting that the securing nails have reached the end of their useful life. This roof slope needs to be slipped and re-covered. The slates on this slope are larger than usual and there will inevitably be a need to source additional matching slates. If possible, second-hand slates will be sourced from reputable reclamation yards, however if none can be found then new welsh slate, cut to the correct size will be obtained. The Historic Building Consultant will ensure that any replacement slate will accurately match existing.

These slopes are in relatively sound condition and will only require minor attention. No re-covering needed.

These 4 hipped slopes are in sound condition and will only require minor attention. No re-covering needed.

The structural engineer's report details the structural problems with this roof and the proposed method to remedy the defects. In general, the whole roof has dropped causing spread at the eaves. The ridge has followed the roof down leaving the distinct "dip". The entire roof needs to be stripped, the structure raised onto a new ridge beam and rafters repaired at eaves. The covering will then be re-laid with all new leadwork.

This lean-to slope is in sound condition and will only require minor attention. No re-covering needed.

This Cotswold stone slated slope is in sound condition and will only require minor attention. No re-covering needed.

The slates on this north facing slope have started to slip and there are a number of broken and split slates. This slope will need to be re-covered. Extreme care will need to be taken to lift the stone ridge so that it can be reinstated. Any damaged stone will be replaced in matching stone and all ridge pieces laid in lime mortar.

This lean-to slope is in sound condition and will only require minor attention. No re-covering needed. The extensive growth of moss needs to be carefully removed.

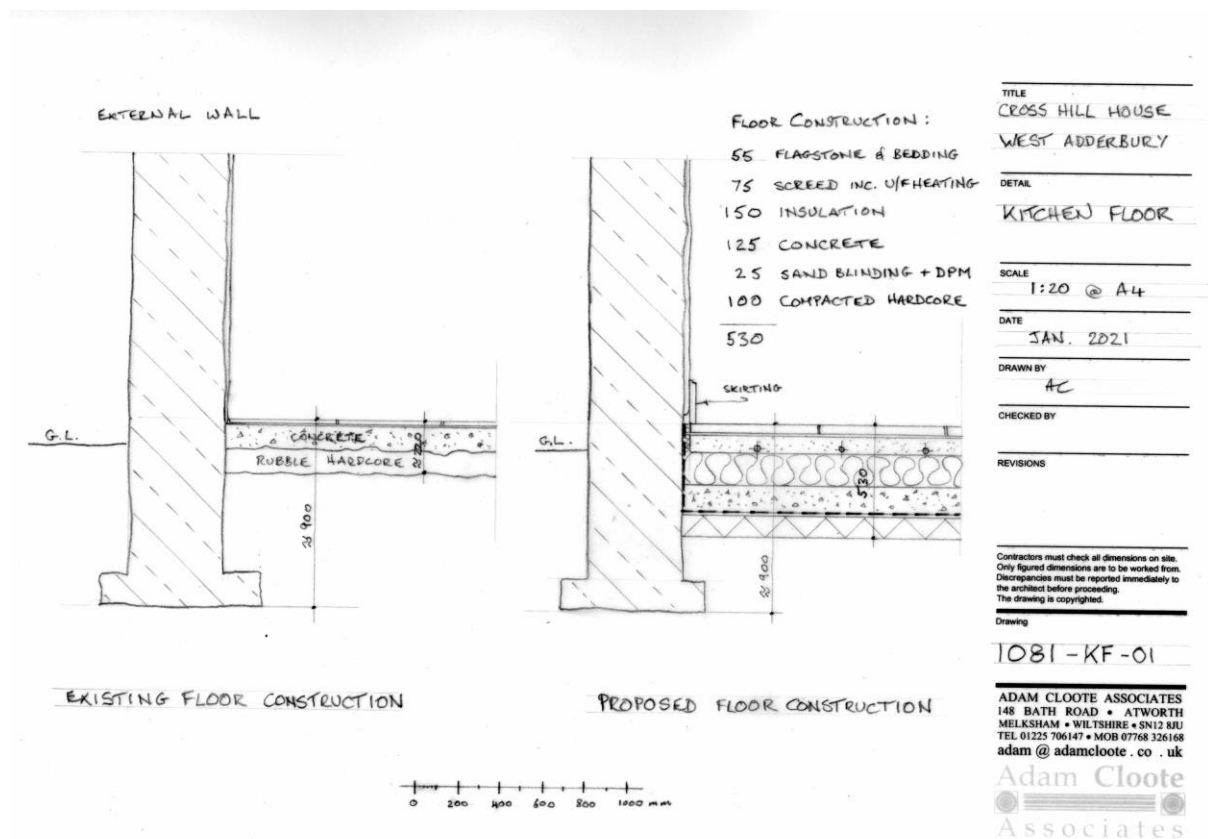
Trial excavations have been undertaken at 5 locations around the perimeter of the room to ascertain the depth of wall footings and to ensure that proposed excavations do not undercut those footings. At all 5 locations, projecting stone footings were found at an average depth of approx. 800mm below ground level and approx. 900mm below floor level. The overall depth of the new floor structure, including the flagstone finish is 530mm. The excavation will therefore cause no detrimental effect to the foundations and the integrity of the structure. See details below:

incorporating insulation to current Building Regulation standards and underfloor heating set within a screed. It will then be topped with new English limestone flagstones.
